Coastal Protection and Restoration Authority of Louisiana

2010/2011 Annual Inspection Report

EAST SABINE LAKE HYDROLOGIC RESTORATION PROJECT (CS-32)

October 6, 2010
May 10, 2011
Cameron Parish

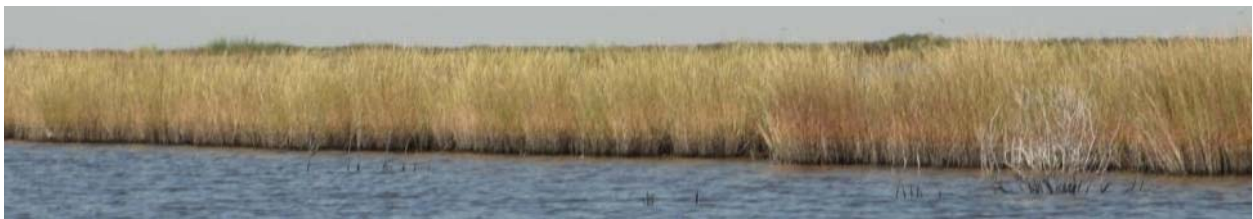
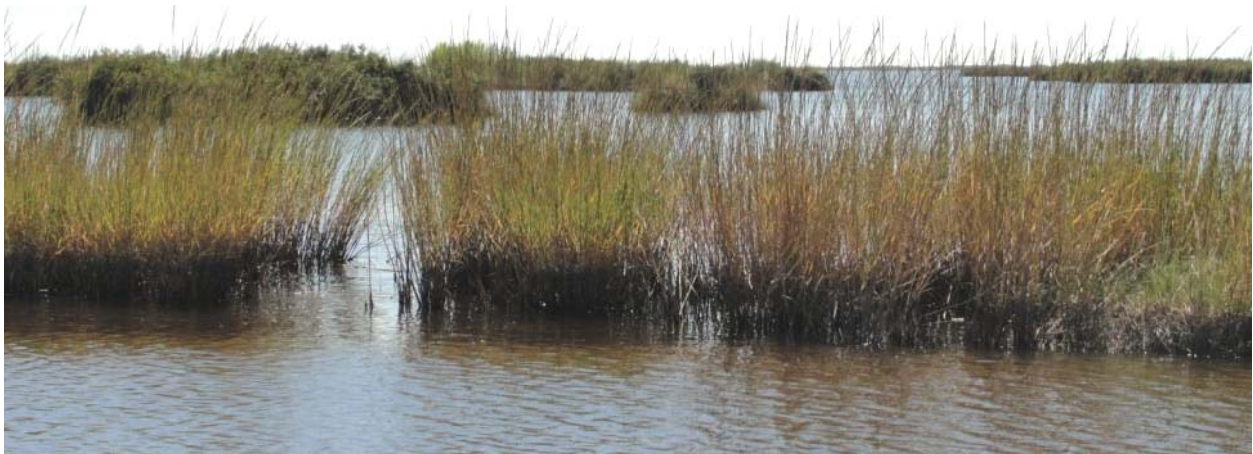
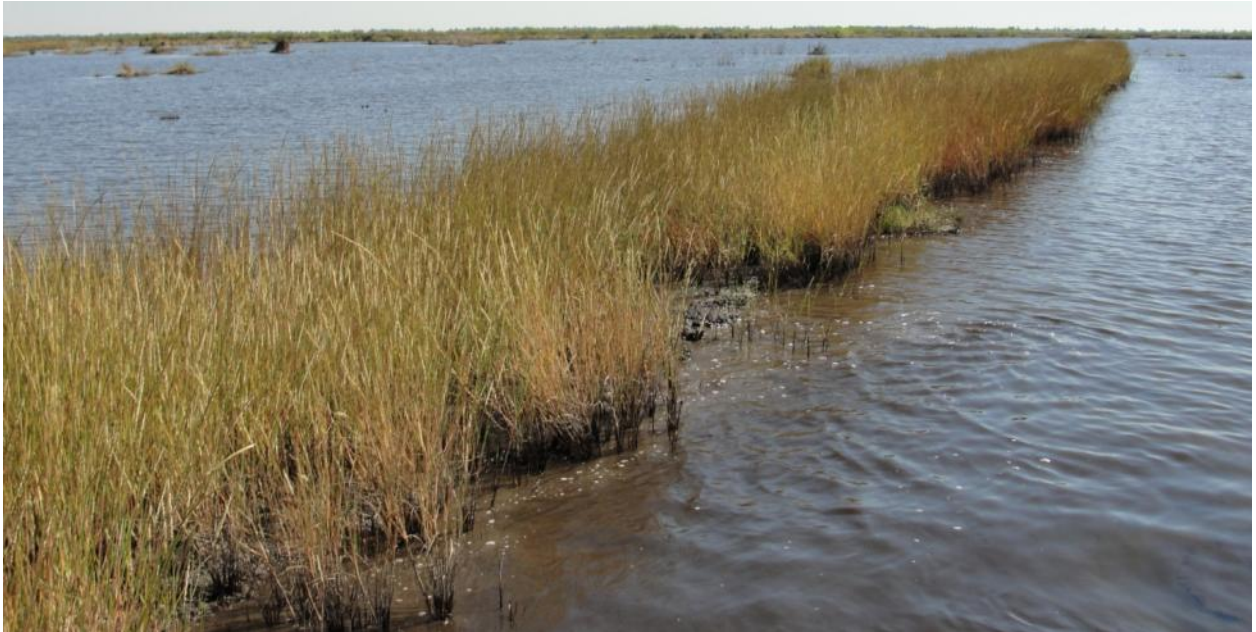
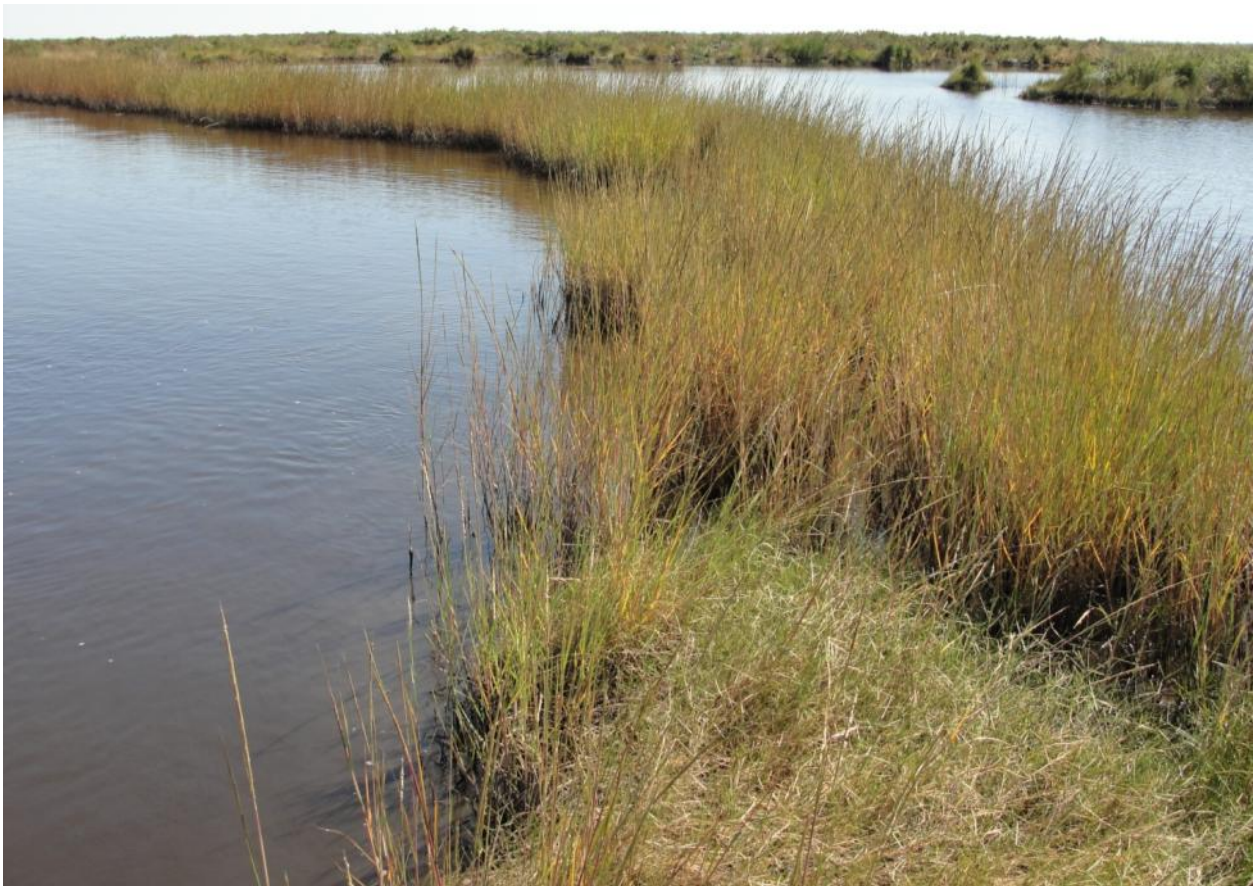
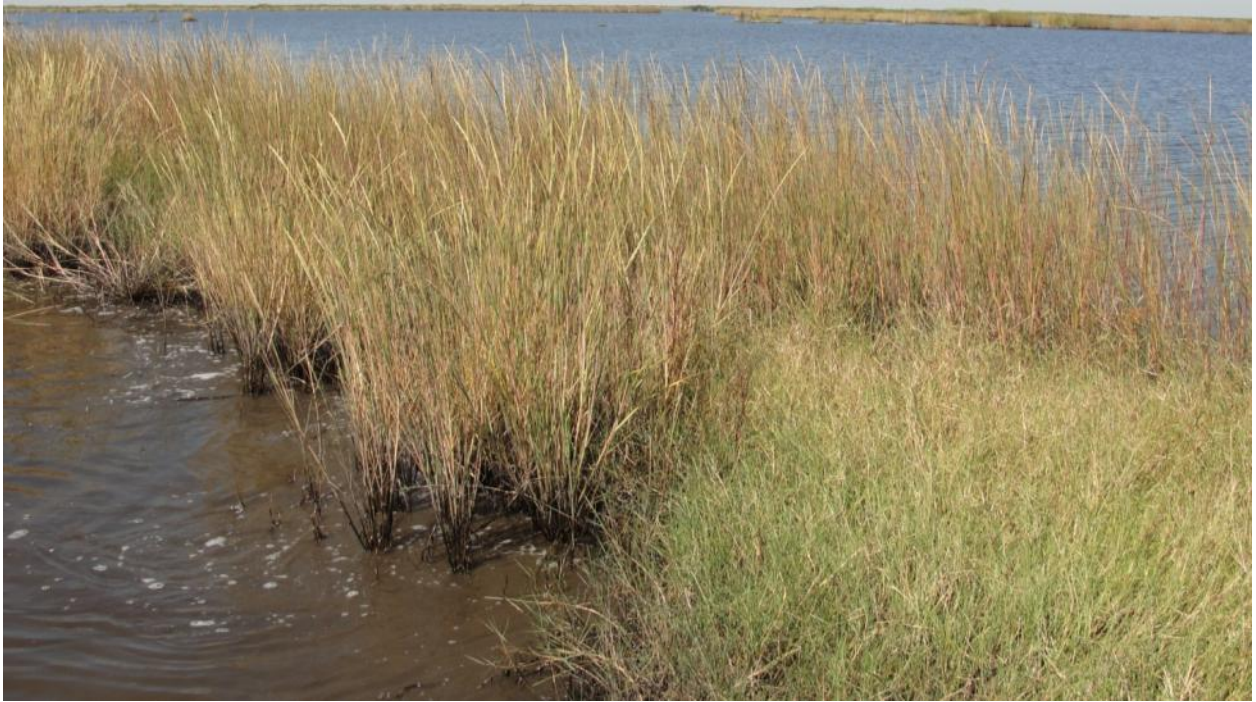
The vegetative growth of smooth cordgrass on the oldest and southeasternmost CU-1 Rows 16 to 25 looked excellent, as did that on newer CU-1A/B Rows 11 to 8, and the coverage was nearly 100%. The few gaps that were occasionally present on a few segments were minor and some gaps were occupied by other species such as seashore paspalum (*Paspalum vaginatum*) where the terrace crown was above the water elevation on this date.

The estimated survival of the newer CU-1A/B plantings was very good in Rows 5 to 11 (greater than 80%), although the size of the gaps were more significant and narrowing of some terrace segments became more noticeable as we neared Row 5.

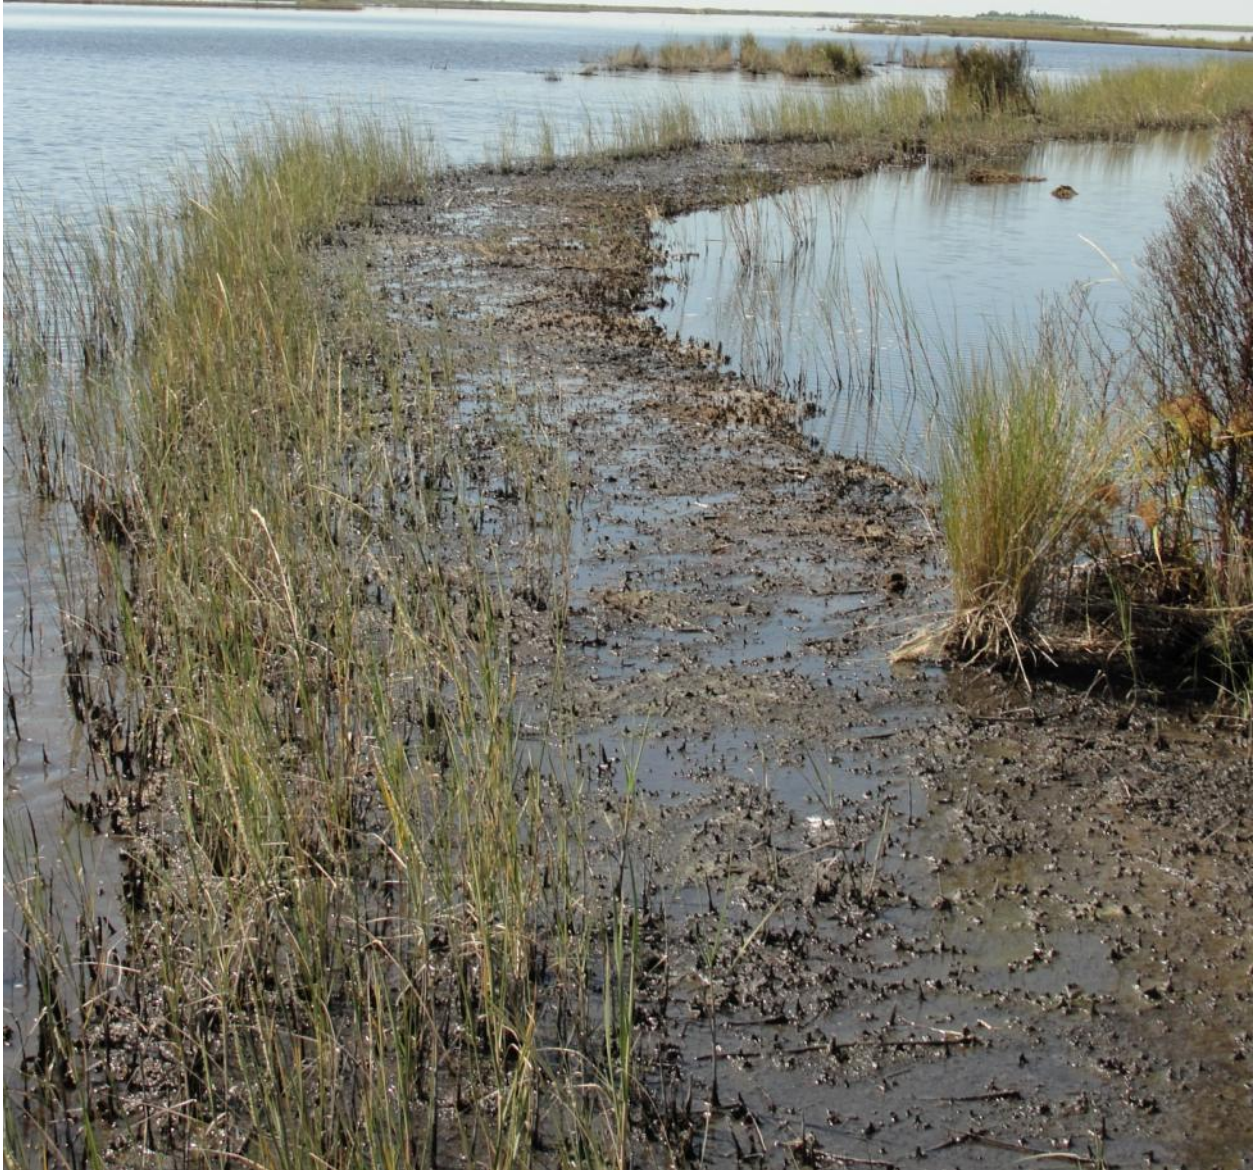
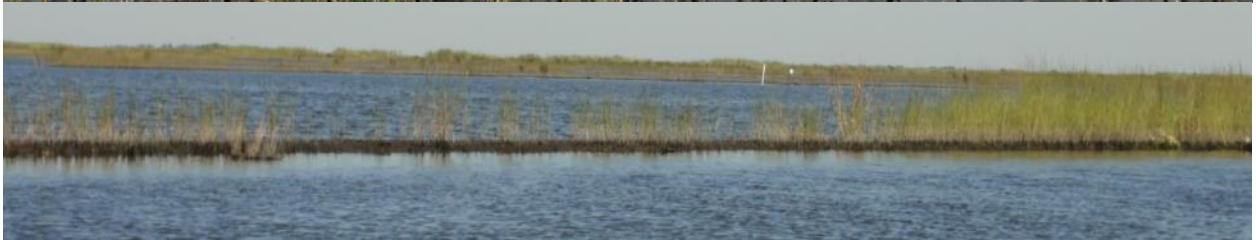
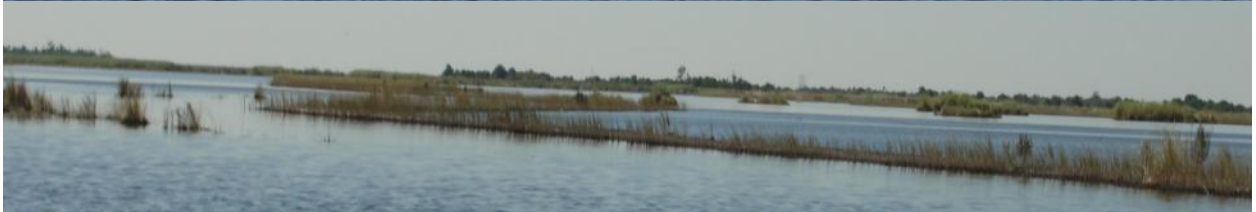
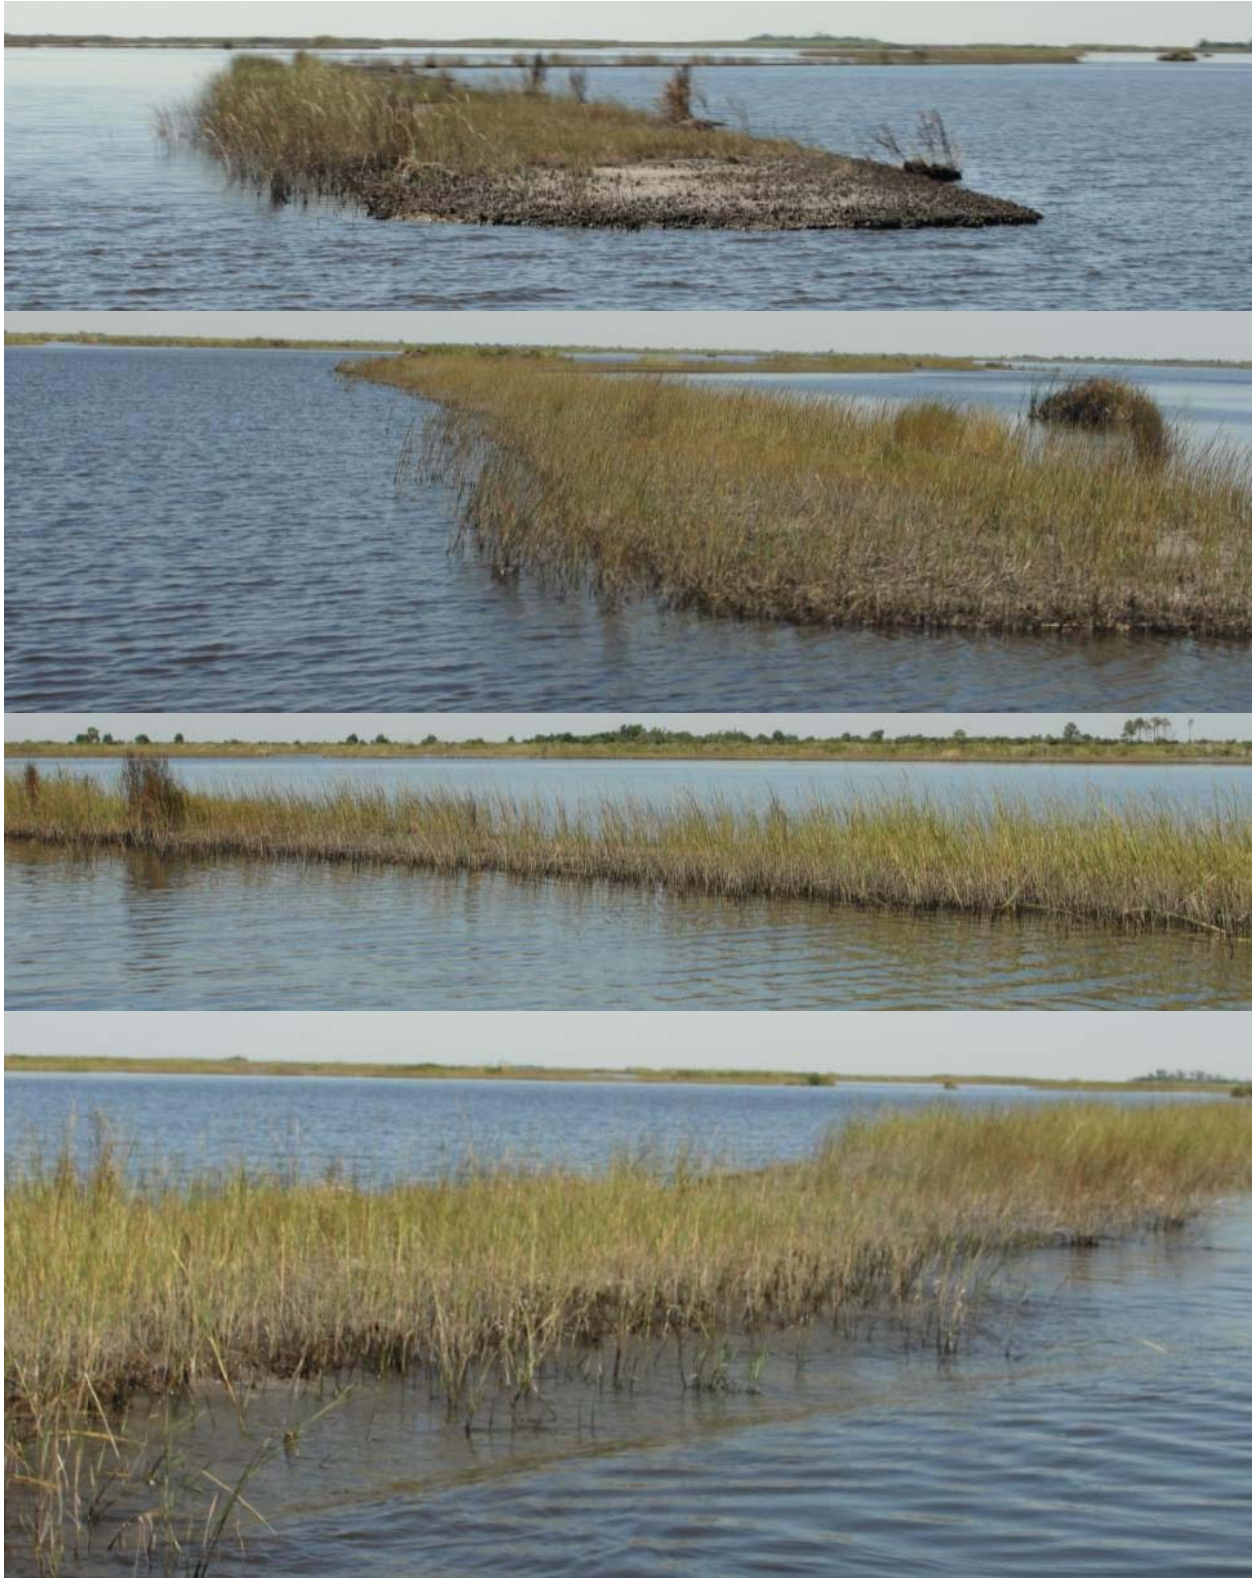
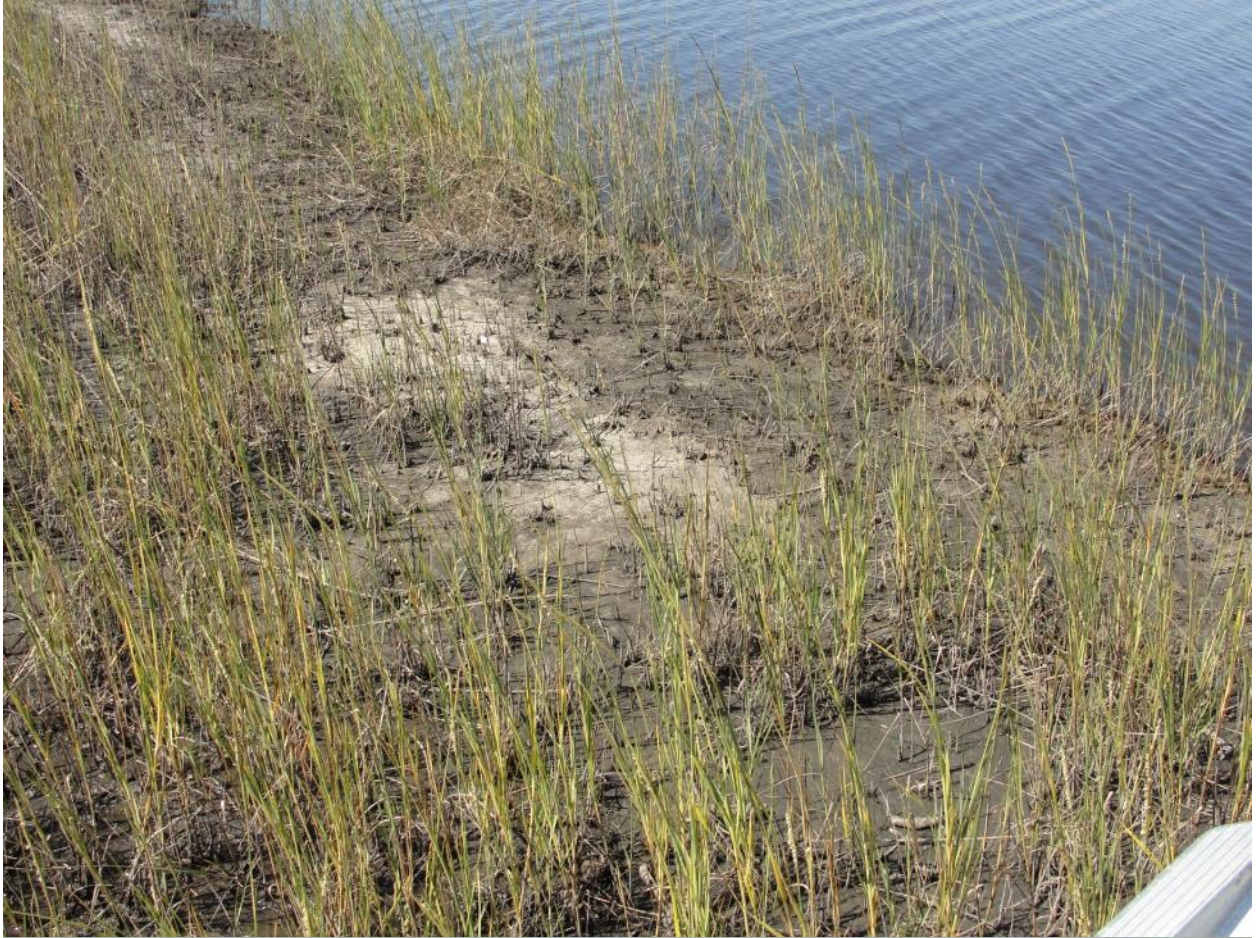
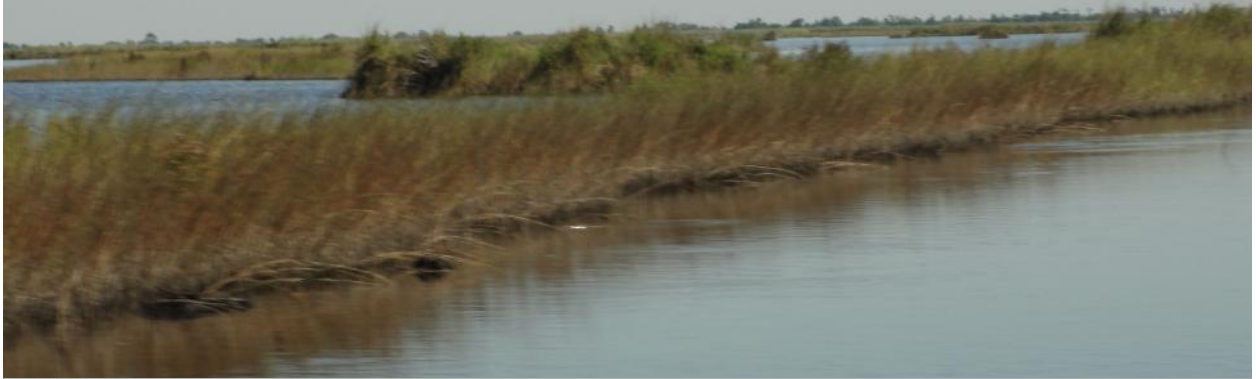
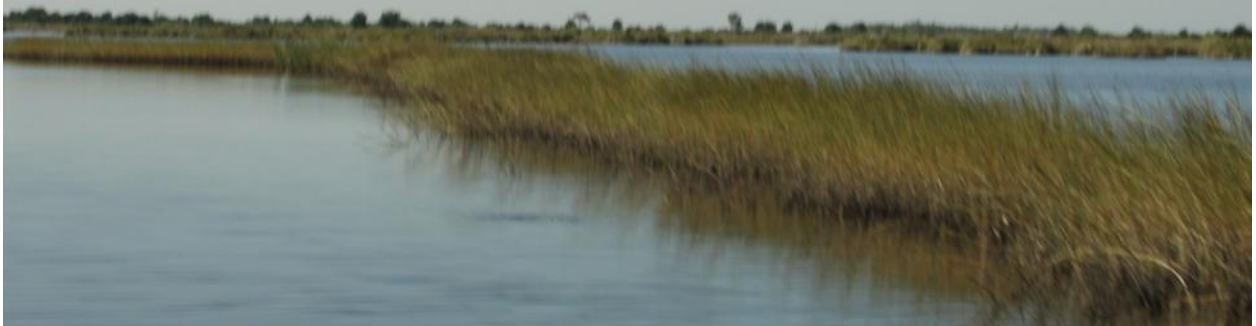
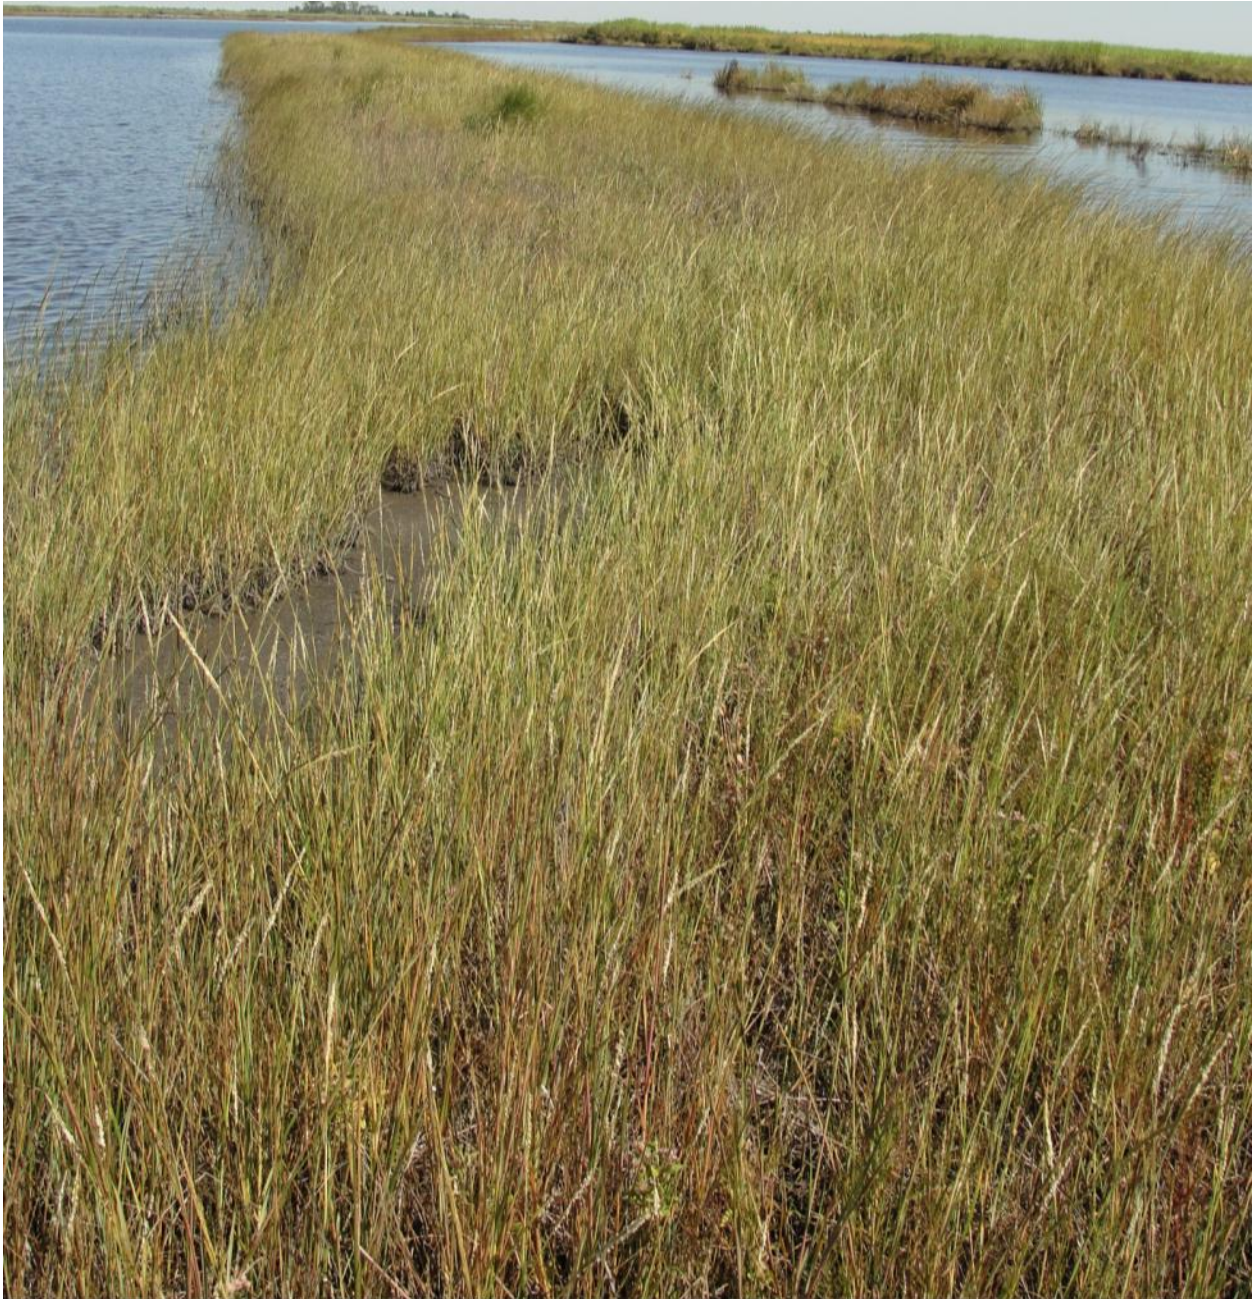
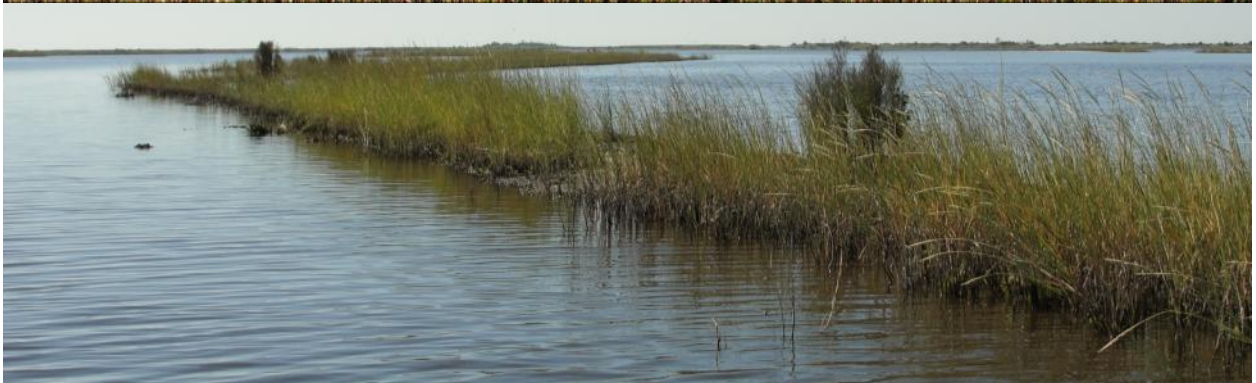
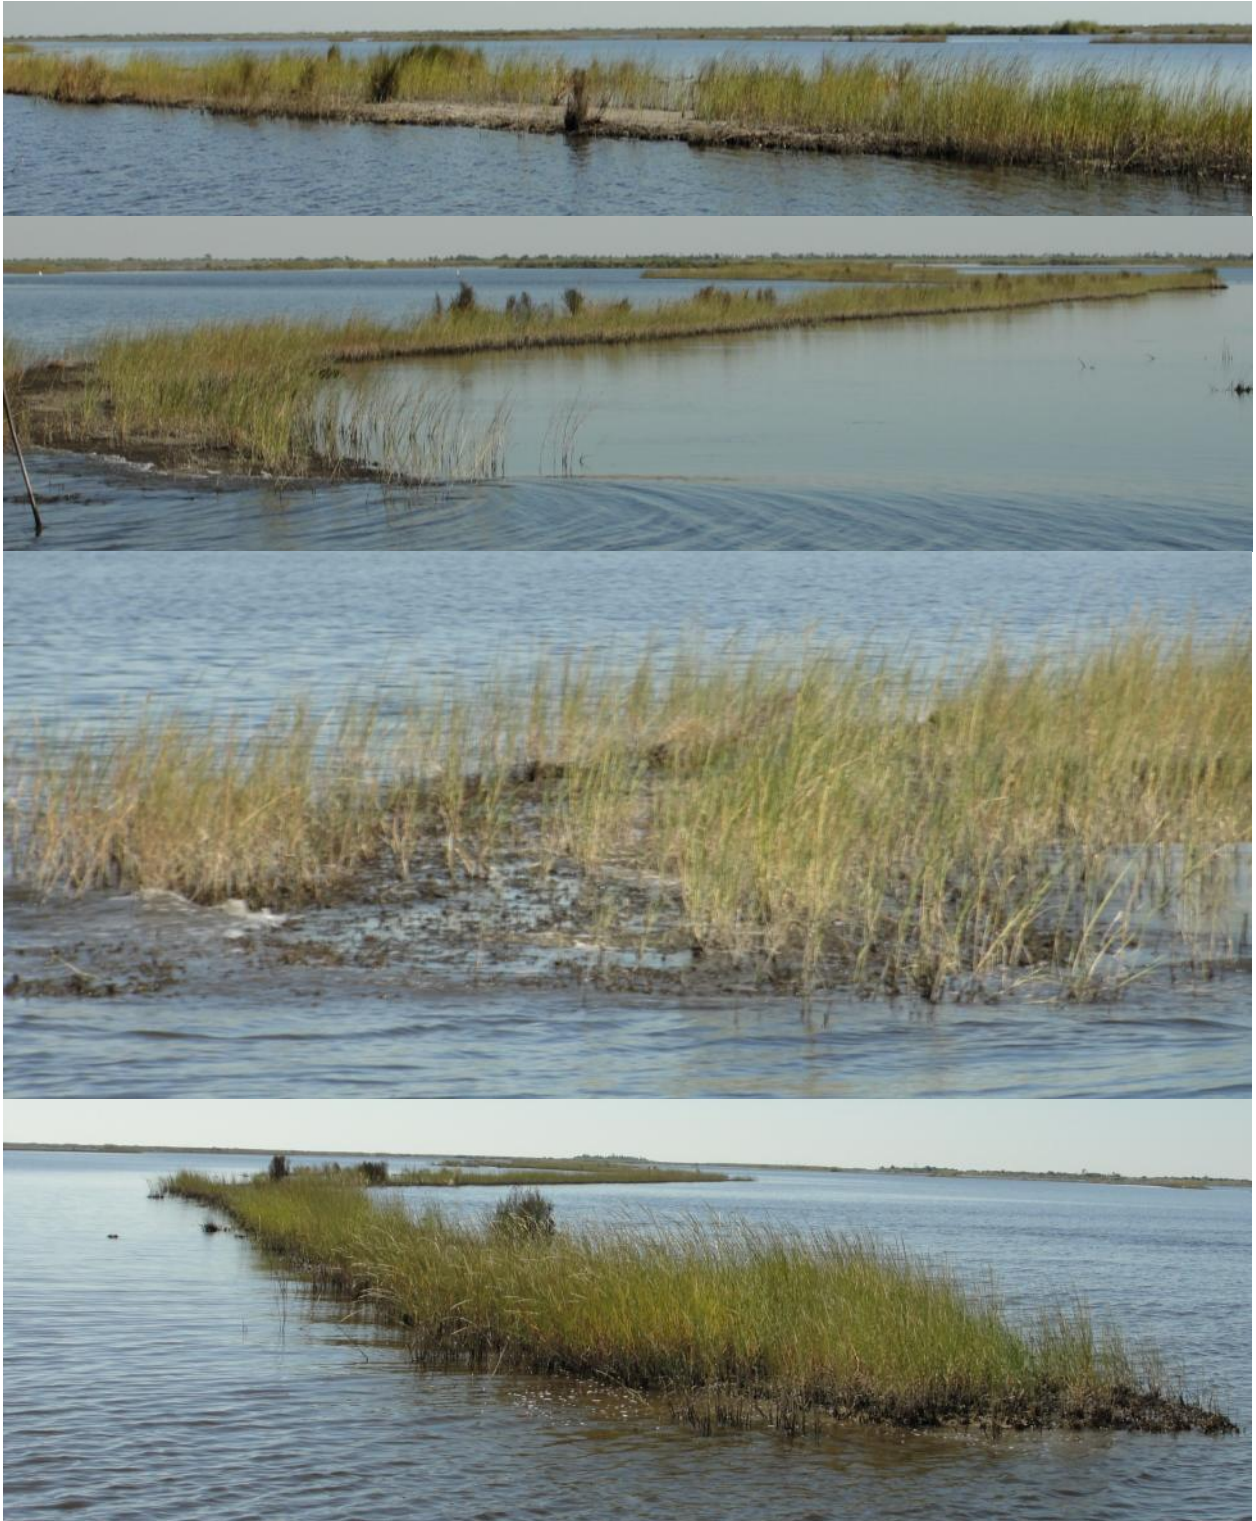
Continuing north, the survival and cover on the CU-1 terraces was found to vary quite a lot. Many terrace segments were much narrower and had poor to no cover, but there were other segments where the cover was good and the terraces retained their width. Overall though, there were only a few sites found where individual smooth cordgrass plants looked as robust as those seen to the south. It almost appeared that some plantings were just beginning to re-emerge and expand the cover.

The water salinity and soil EC data, and the vegetative coverage estimates recorded by the field party are attached. A lot of photographs have been included in this report to fully illustrate just how widely the condition of the terraces and plantings ranged over the 221,000 LF (nearly 42 miles) of terraces. Over the entire project, I would estimate that vegetative cover of the terraces is at approximately 50%. The impact of the combination of storms and

repeated years of drought had been extreme, although the current soil and water salinity/EC conditions on this date were well within tolerable ranges for smooth cordgrass. A large portion of the remaining plantings still appear to be in a recovery mode and may just require more time to achieve desired vigor and expansion.

Recommendation: The project team discussed options and it is recommended that the construction phase of this project be closed out. The remaining plantings are expected to continue to recover and expand but where there are large stretches of missing plants, it is advisable to re-vegetate with additional plantings that can be conducted through O&M. I recommend that an O&M planting to target areas with poor to no cover be planned for TY1 or 2, and could probably be accomplished for less than \$100,000 (not amortized \$). To provide for adequate cover to be maintained throughout the 20-year project life, O&M funds should also be available for an additional O&M planting event if it becomes necessary later in the project life. Darryl Clark has confirmed that there currently is \$254,428.04 in the project O&M budget, which is sufficient to fund a TY1 or 2 planting. OCPR typically implements the O&M activities, but if USFWS & OCPR agree, NRCS can design and implement the planting.

The condition of the terraces and plantings should be reassessed again by the end of October 2011 at which time a more accurate estimate of the replanting needs will be made.
